TABLE OF CONTENTS

1.0 METHODOLOGY

The goal of this project, funded by a Non-Motorized Transportation Pilot Program award from Bike/Walk Twin Cities (BWTC) administered by Transit for Livable Communities (TLC), was to compile a list of infrastructure improvements that would improve bicycle and pedestrian connections to transit within the project study area (Figure 1). Communities can then use this list to apply for funding to complete identified improvements through Transit for Livable Communities' Bike/Walk Twin Cities program or other funding sources if they choose to do so.

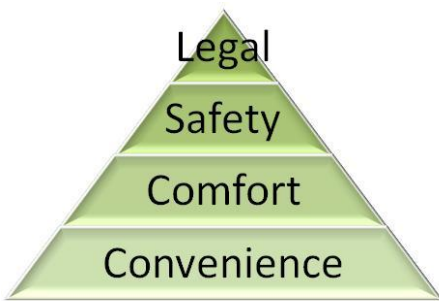
Source: Prioritization of Issues that affect Transit Use, TLC

The TAC helped to identify and rank variables that affect access and convenience of use. The pyramid to the left represents the prioritization of issues that affect pedestrian/bicycle use of transit. Following the general principal of the triangular graphic, access to meet legal ADA requirements, is most critical. Once this legal access is gained, safety becomes the next critical issue. As the categories of issues are addressed from the top of the

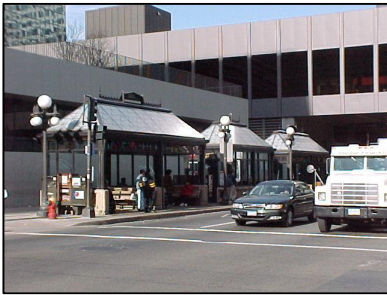
Metropolitan Transit Bus Shelter
 Source: HR Green

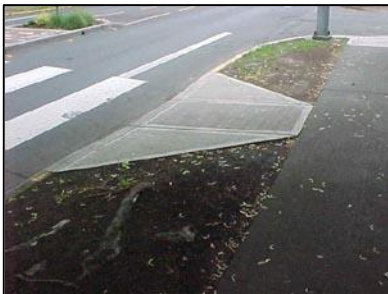
Pedestrian Curb Cut/ADA Ramp
 Source: City of Portland

A typical 5'x18' pedestrian curb cut and ADA ramp was used to allow for ADA access. For cost estimate purposes, a pedestrian curb cut and ADA ramp was recommended at all deficient stops. For more images refer to:

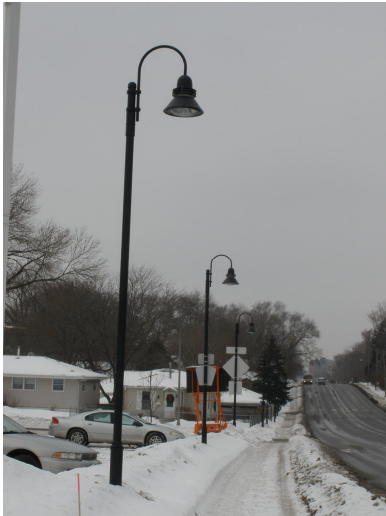
Pedestrian Scale Lighting
 Source: HR Green

The installation of a 12' to 15' tall lighting fixture was used to provide illumination for the sidewalk and roadway. It was assumed the cost includes both installation and cost of the fixture. For cost estimate purposes, pedestrian scale lighting was generally not included. Stops that have a lighting deficiency are accounted for under the Street Light item. Pedestrian scale lighting is a good option and should be considered on a project by project basis.

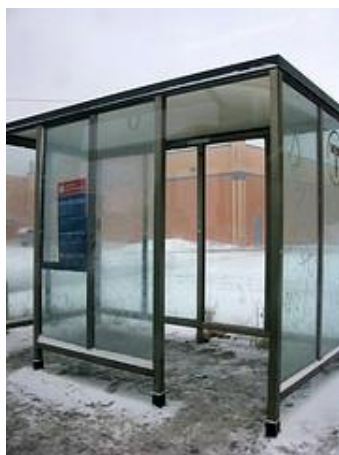
Metropolitan Transit Shelter
 Source: HR Green

The cost and installation of a typical shelter (6'x8'). For cost estimate purposes, a shelter was recommended every 3rd stop.

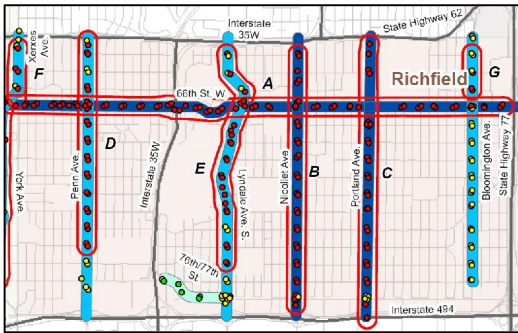
RICHFIELD

Traffic volumes are too high to recommend a road diet, much of the corridor already had a center shared turn lane. A complete street concept would be needed to add bike lanes to this project area. This would require major reconstruction of the roadway. The majority of the bike safety issues are at the intersection of 66th Street and York Ave, an intersection improvement project is recommended to make this intersection pedestrian and bike friendly.

Median treatment is recommended on 66th from Lake Shore Dr to 1st Ave, median treatment would discourage mid-block crossing through this commercial zone and improve pedestrian safety. A Hawk Signal system could be utilized in this same vicinity to provide an efficient and safe means for pedestrians to cross 66th.

There are many locations along 66th St that have deficient lighting near bus stops. Pedestrian level lights near the bus stops would improve pedestrian safety.

The corridor project contains locations along 66th Street that have deficient facilities near bus stops. Improvements, such as ADA access, painted or raised crosswalks, benches, bike lockers, shelters, and trash receptacles would facilitate accessibility and the transit experience.

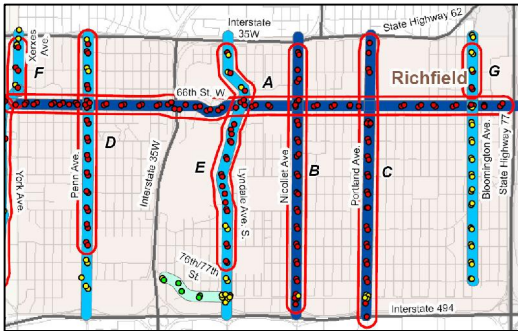
Richfield B

The north-south route along Nicollet Avenue in Richfield was identified as a corridor project. This proposed project runs the entire length of Nicollet Avenue from Highway 62 on the northern end through Interstate 494 along the southern edge of Richfield. This was a result of observing similar patterns in the various GIS mapping exercises along this Richfield corridor. The criteria used to evaluate this corridor included: lighting, crosswalk access, bike lockers, bike lane access, bike crashes, pedestrian crashes, benches, ADA access, ADA pads, right-of-way buffers, shelters, sidewalk access and Level of Service rankings. As a result of the analysis, the corridor was identified as a high priority project.

Median treatment is recommended on Nicollet from 64th St to 67th St, median fences will discourage mid block crossing through this commercial zone and improve pedestrian safety.

The corridor project contains locations along Nicollet Avenue that have deficient site facilities near bus stops Improvements, such as ADA access, painted or raised crosswalks, benches, bike lockers, shelters, and trash receptacles would facilitate accessibility and the transit experience.

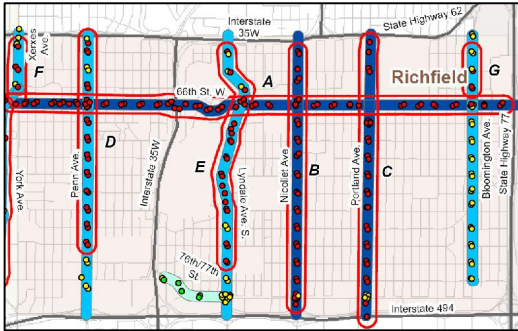
Richfield C

The north-south route along Portland Avenue in Richfield was identified as a corridor project. This proposed project runs the entire length of Nicollet Avenue from Highway 62 on the northern end through Interstate 494 along the southern edge of Richfield. This was a result of observing similar patterns in the various GIS mapping exercises along this Richfield corridor. The criteria used to evaluate this corridor included: lighting, crosswalk access, bike lockers, bike lane access, bike crashes, pedestrian crashes, benches, ADA access, ADA pads, right-of-way buffers, shelters, sidewalk access and Level of Service rankings. As a result of the analysis, the corridor was identified as a high priority project.

The cluster project contains locations along Portland Avenue that have deficient site facilities near bus stops. Improvements, such as ADA access, painted or raised crosswalks, benches, bike lockers, shelters, and trash receptacles would facilitate accessibility and the transit experience.

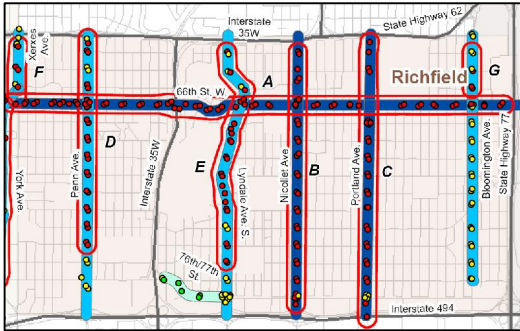
Richfield E

The north-south route along Lyndale Avenue in Richfield was identified as a corridor project. This proposed project runs from Highway 62 along the northern edge of Richfield through W. 75th Street in southern Richfield. This was a result of observing similar patterns in the various GIS mapping exercises along this Richfield corridor. The criteria used to evaluate this corridor included: lighting, crosswalk access, bike lockers, bike lane access, bike crashes, pedestrian crashes, benches, ADA access, ADA pads, right-of-way buffers, shelters, sidewalk access and Level of Service rankings. As a result of the analysis, the corridor was identified as a high priority project.

Median treatment is recommended on Lyndale from 64th St to 67th St. Median fences will discourage mid block crossing through this commercial zone and improve pedestrian safety.

The corridor contains locations along Lyndale Avenue that have deficient site facilities near bus stops Improvements, such as ADA access, painted or raised crosswalks, benches, bike lockers, shelters, and trash receptacles would facilitate accessibility and the transit experience.

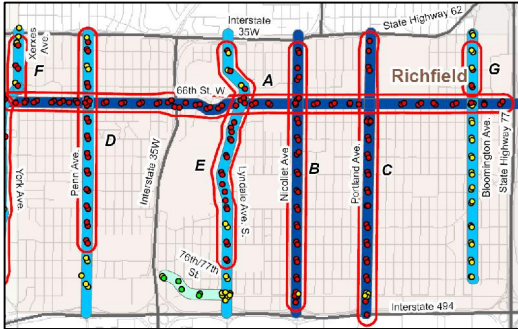
Richfield F

The north-south route along Xerxes Avenue in Richfield was identified as a cluster project. This proposed project runs from Xerxes Avenue along the western edge of the City through 66th Street in northwestern Richfield. This was a result of observing similar patterns in the various GIS mapping exercises along this Richfield corridor. The criteria used to evaluate this corridor included: lighting, crosswalk access, bike lockers, bike lane access, bike crashes, pedestrian crashes, benches, ADA access, ADA pads, right-of-way buffers, shelters, sidewalk access and Level of Service rankings. As a result of the analysis, the corridor was identified as a high priority project.

The cluster project contains locations along Xerxes Avenue that have deficient site facilities near bus stops. Improvements, such as ADA access, painted or raised crosswalks, benches, bike lockers, shelters, and trash receptacles would facilitate accessibility and the transit experience.

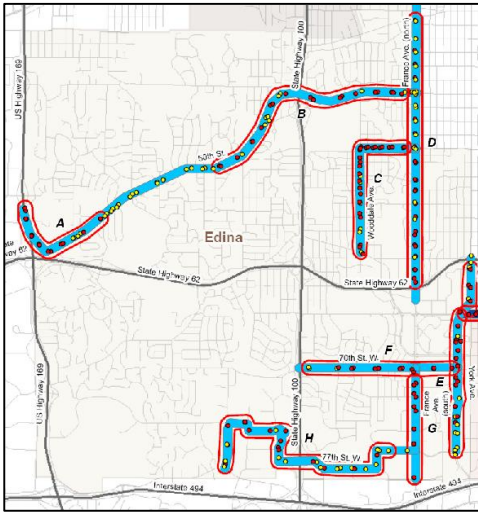
Edina F

The identified corridor project runs north/south along Xerxes Avenue S. from W. 66th Street to Highway 62 along the northern edge. This was a result of observing similar patterns in the various GIS mapping exercises along this Edina corridor. The criteria used to evaluate this corridor included: lighting, crosswalk access, bike lockers, bike lane access, bike crashes, pedestrian crashes, benches, ADA access, ADA pads, right-of-way buffers, shelters, sidewalk access and Level of Service rankings. As a result of the analysis, the corridor was identified as a high priority project.

There are many locations along Xerxes Avenue that have deficient lighting near bus stops. Pedestrian level lights near the bus stops would improve pedestrian safety.

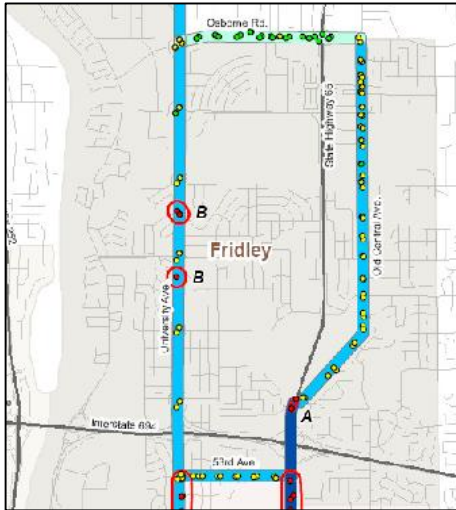
Fridley A

There are a few locations along Central Avenue/Highway 65 that have deficient ADA pads near bus stops. Upgrading the pads and other site facilities, such as adding benches, bike lockers, shelters and trash receptacles near the bus stops would improve safety and accessibility and the transit experience.

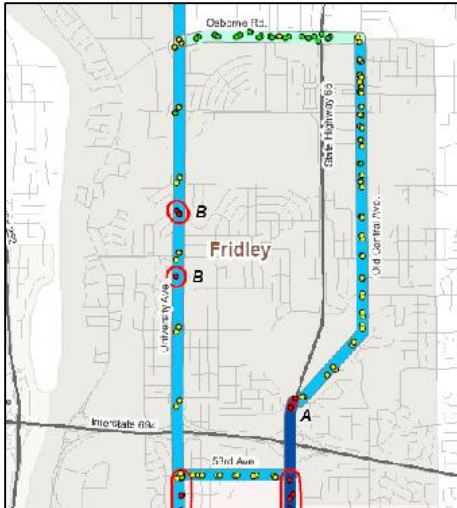
Fridley B

The identified cluster project is located along University Avenue NE at the intersection of Satellite Lane NE and University Avenue NE and the intersection of Rice Creek Terrace NE and University Avenue NE. This was a result of observing similar patterns in the various GIS mapping exercises along this Fridley corridor. The criteria used to evaluate this corridor included: lighting, crosswalk access, bike lockers, bike lane access, bike crashes, pedestrian crashes, benches, ADA access, ADA pads, right-of-way buffers, shelters, sidewalk access and Level of Service rankings. As a result of the analysis, the corridor was identified as a high priority project.

There are many locations along University Avenue NE that have deficient lighting near bus stops. Pedestrian level lights near the bus stops would improve pedestrian safety.

There are a couple locations along University Avenue NE that have deficient ADA pads near bus stops. Upgrading the pads and other site facilities near the bus stops would improve safety and accessibility and the transit experience.

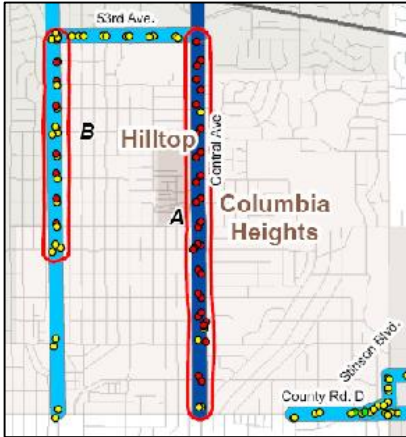
Columbia Heights A

There are many locations along Central Avenue NE that have deficient lighting near bus stops. Pedestrian level lights near the bus stops would improve pedestrian safety.

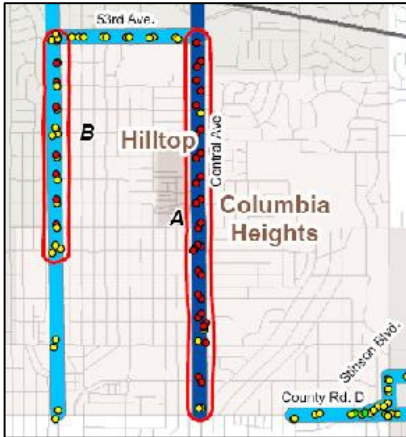
Columbia Heights B

The identified corridor project runs north/south along University Avenue NE from 44th Avenue NE in the south to 52nd Avenue NE to the north. This was a result of observing similar patterns in the various GIS mapping exercises along this Columbia Heights corridor. The criteria used to evaluate this corridor included: lighting, crosswalk access, bike lockers, bike lane access, bike crashes, pedestrian crashes, benches, ADA access, ADA pads, right-of-way buffers, shelters, sidewalk access and Level of Service rankings. As a result of the analysis, the corridor was identified as a high priority project.

There are many locations along University Avenue NE that have deficient site facilities near bus stops. Pedestrian level improvements, such as, ADA access, painted crosswalks, benches, bike lockers, shelters, and trash receptacles facilitate accessibility and the transit experience.

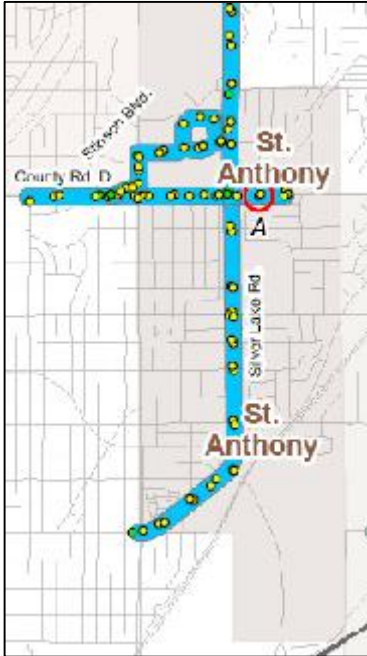
St. Anthony A

There are many locations along 37th Avenue NE that have deficient site facilities near bus stops. Improvements, such as ADA access, painted or raised crosswalks, benches, bike lockers, shelters, and trash receptacles would facilitate accessibility and the transit experience.

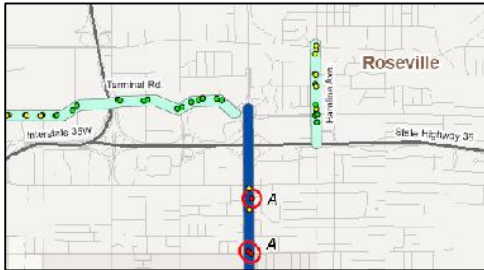
Roseville A

There are many locations along Snelling Avenue that have deficient site facilities near bus stops. Improvements, such as ADA access, painted or raised crosswalks, benches, bike lockers, shelters, and trash receptacles would facilitate accessibility and the transit experience.

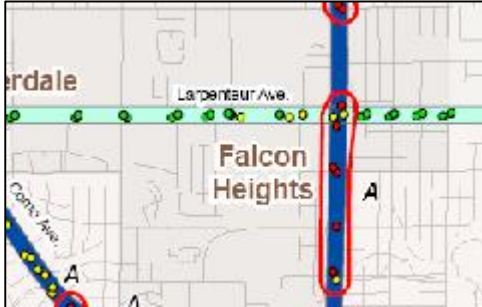
Falcon Heights A

There are many locations along Snelling Avenue that have deficient site facilities near bus stops. Improvements, such as ADA access, painted or raised crosswalks, benches, bike lockers, shelters, and trash receptacles would facilitate accessibility and the transit experience.

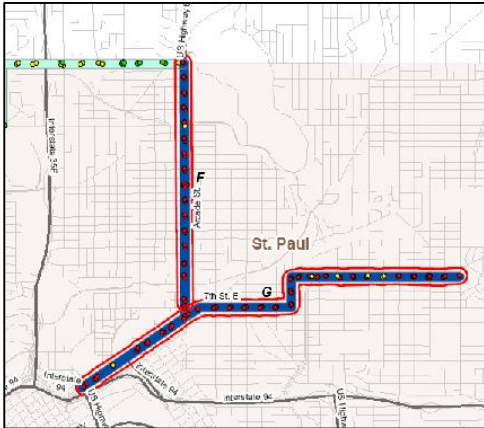
St. Paul G

The identified corridor project runs mainly east/west along 7th Street East from Lafayette Road N to Minnehaha Avenue E. The corridor then follows Minnehaha Avenue E from 7th Street E to Atlantic Street N where it turns north/south along Atlantic Street N to 7th Street E. The corridor then follows 7th Street E to Hazel Street N. This was a result of observing similar patterns in the various GIS mapping exercises along this St. Paul corridor. The criteria used to evaluate this corridor included: lighting, crosswalk access, bike lockers, bike lane access, bike crashes, pedestrian crashes, benches, ADA access, ADA pads, right-of-way buffers, shelters, sidewalk access and Level of Service rankings. As a result of the analysis, the corridor was identified as a high priority project.

- A) ADA Pads
- B) Crosswalk (paint)
- C) Median/Refuge islands
- D) Restripe “Road Diet” add bike lane
- E) Benches
- F) Bike lockers
- G) Shelters
- H) Trash receptacles

There are many locations along 7th Street East and Atlantic Street North that have deficient site facilities near bus stops. Improvements, such as, ADA access, painted crosswalks, benches, bike lockers, shelters, and trash receptacles would improve accessibility and the transit experience.

The identified project is a candidate for a road diet; this reduction in vehicle lanes and addition of dedicated bike lanes would reduce automobile accidents, provide room for bikers, and provide a buffer between pedestrians and traffic.
